Test Report 20190801

Temperature rise test for a three way feeder pillar fabricated by EXTEH with JEAN MÜLLER NH fuse switch disconnectors size 2.

Temperature rise test according IEC 61439-1: 2011 for a three way feeder pillar fabricated by EXTEH.

Three way feeder pillar EXTEH
Strip type fuse switch disconnector type SL2 DELTA

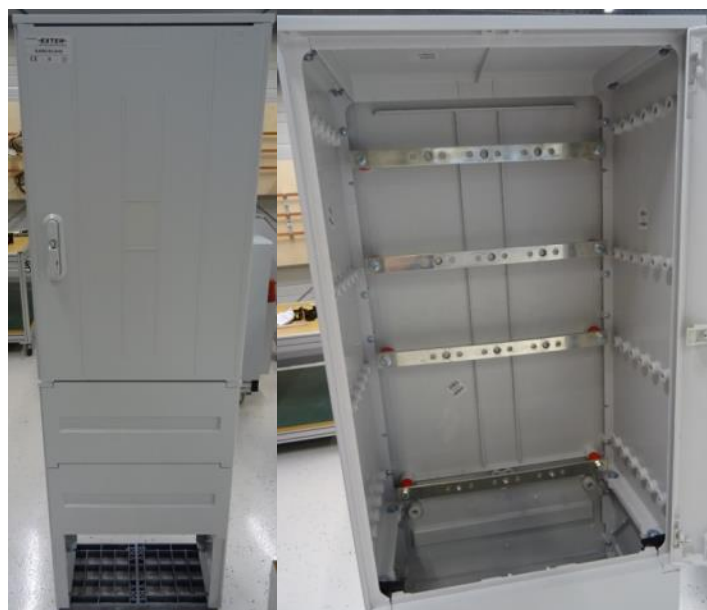
figure 1: test object

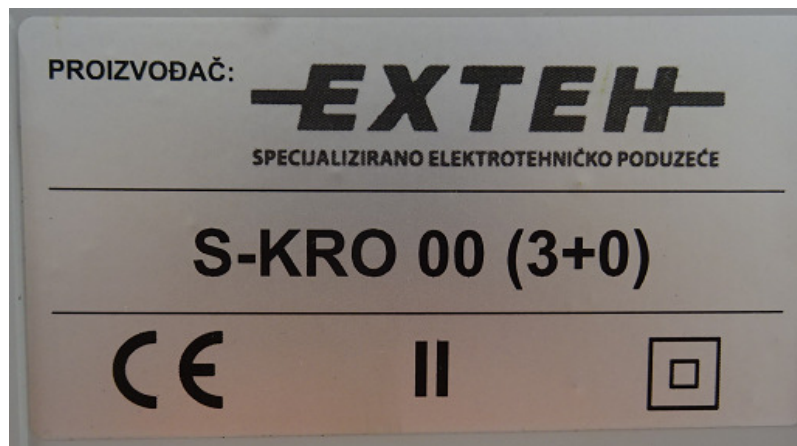
figure 2: type of feeder pillar

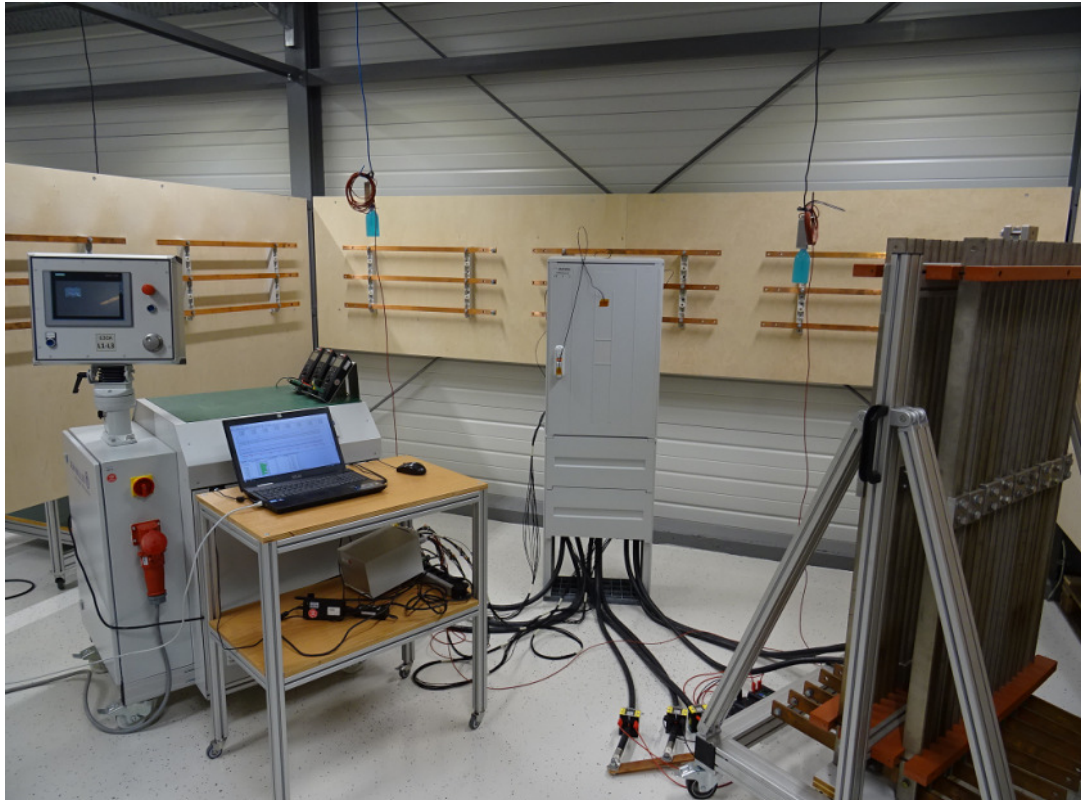
- Busbar (30x10)mm copper / tin coated
- Torque connection strip to busbar: 35Nm
- Torque cable connection: 35Nm
- Cross section cables: 240mm² copper round with cable lug
- Test current in-comer: three-phase 400A ac ±1%

figure 4: test setup

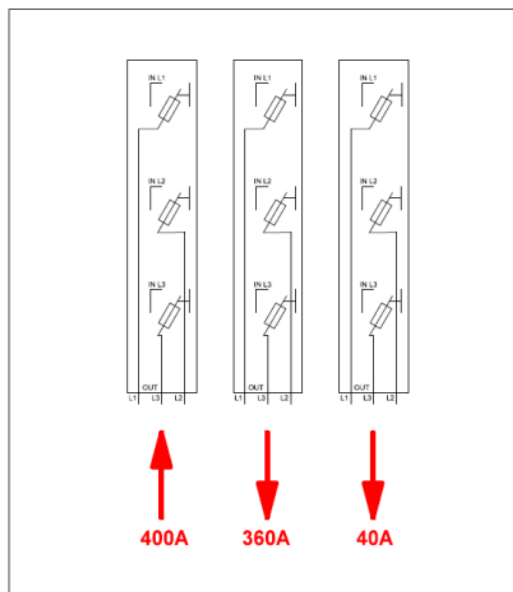
figure 5: test setup

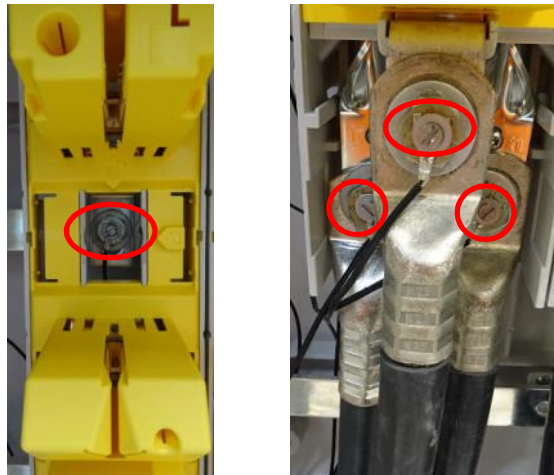
figure 6: Angular lug to busbar, cable connection L1 – L3

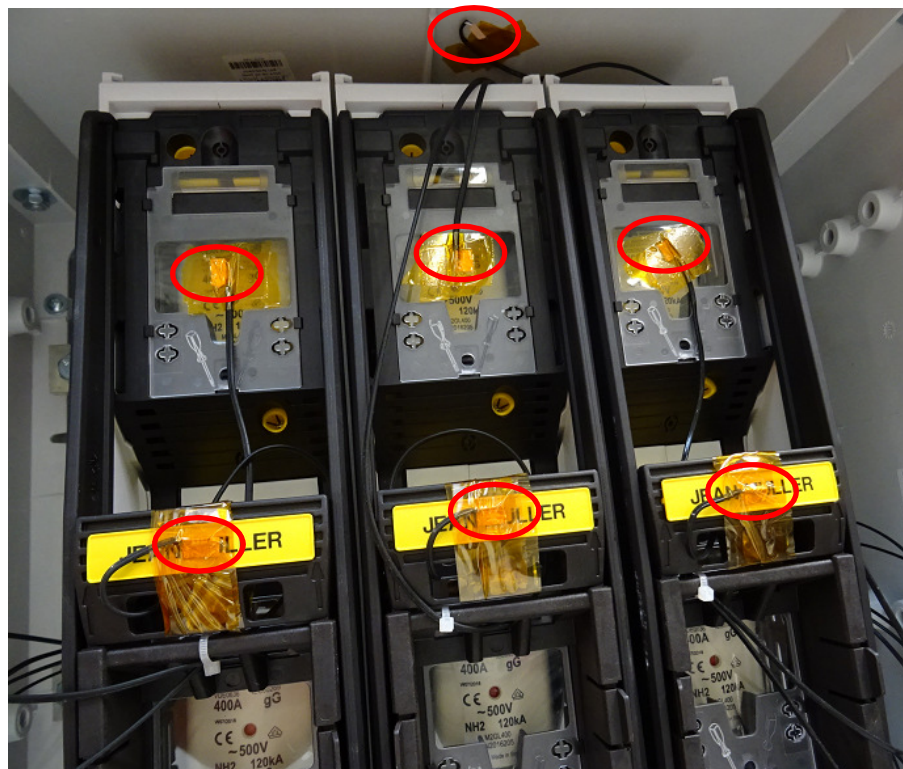
figure 7: Handle, cover L1, internal ambient temperature

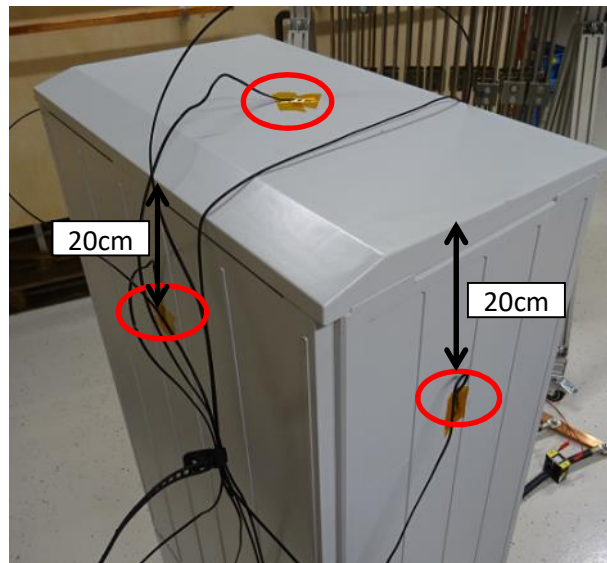
figure 8: Outside rear wall, roof middle, left side

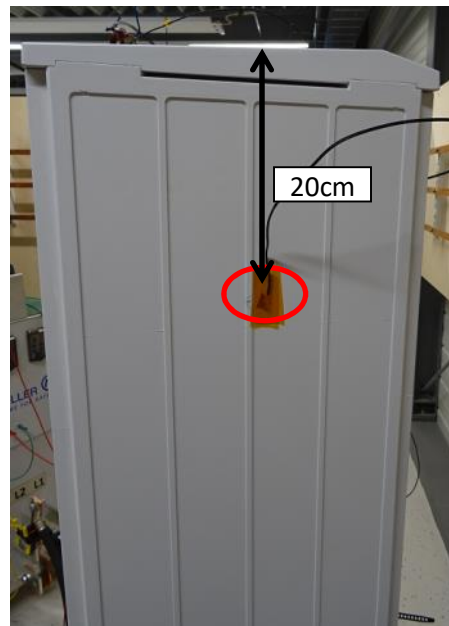
figure 9: Outside right side

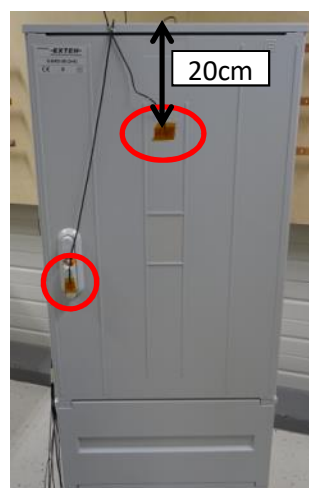
figure 10: Outside front door, handle

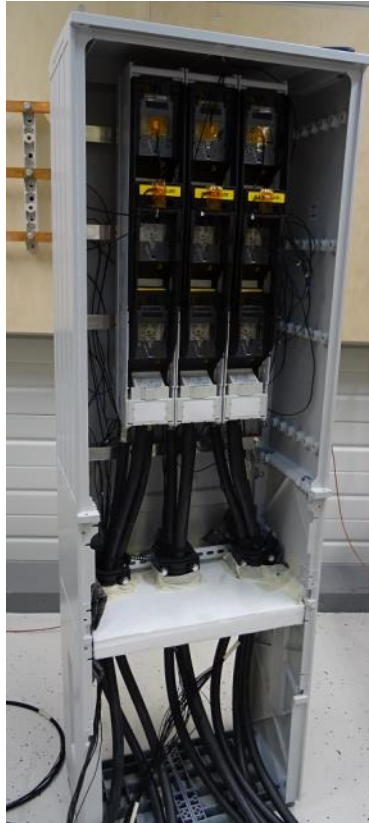
The base of the cabinet is insulated in ground level with 50mm of polystyrene.

figure 11: insulation of base

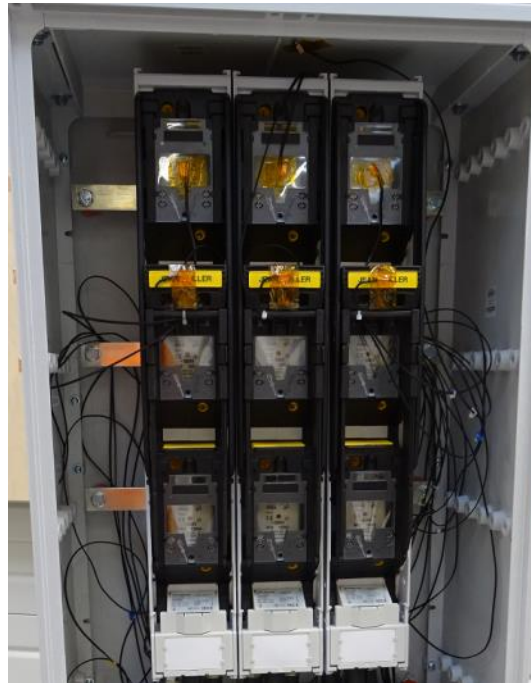
The fuse strips are mounted without any gap in between. The temperature of the strips can be reduced if they are mounted at a distance. This has also a positive influence on the lifetime of the fuse links and the strips.

figure 12: Fuse strips close to each other

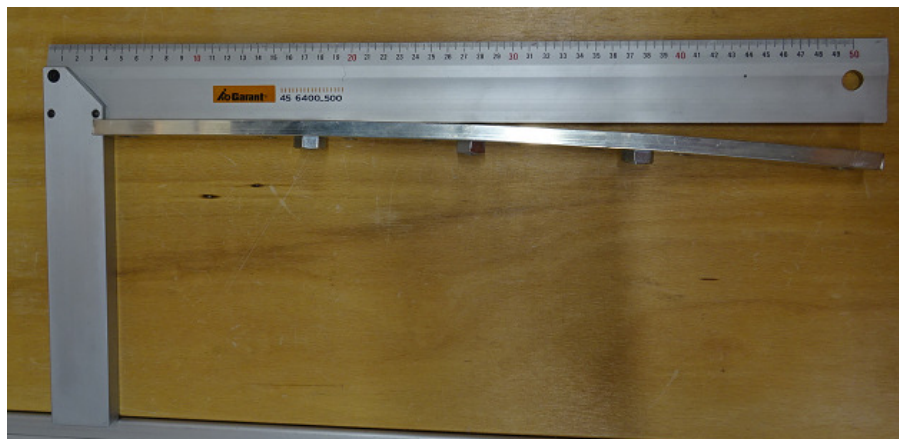
The busbars are not straight which reduces the possible contact points between strip and busbar.

figure 13: Busbars not straight
